**FINAL DRAFT**  
**REMEDIAL INVESTIGATION ADDENDUM:**  
**SUPPLEMENTAL PRELIMINARY ASSESSMENT**  
**OF THE**  
**WILLAMETTE COVE UPLAND FACILITY**  
**PORTLAND, OREGON**

**Port of Portland**  
**121 NW Everett**  
**Portland, Oregon 97209**

**September 19, 2003**

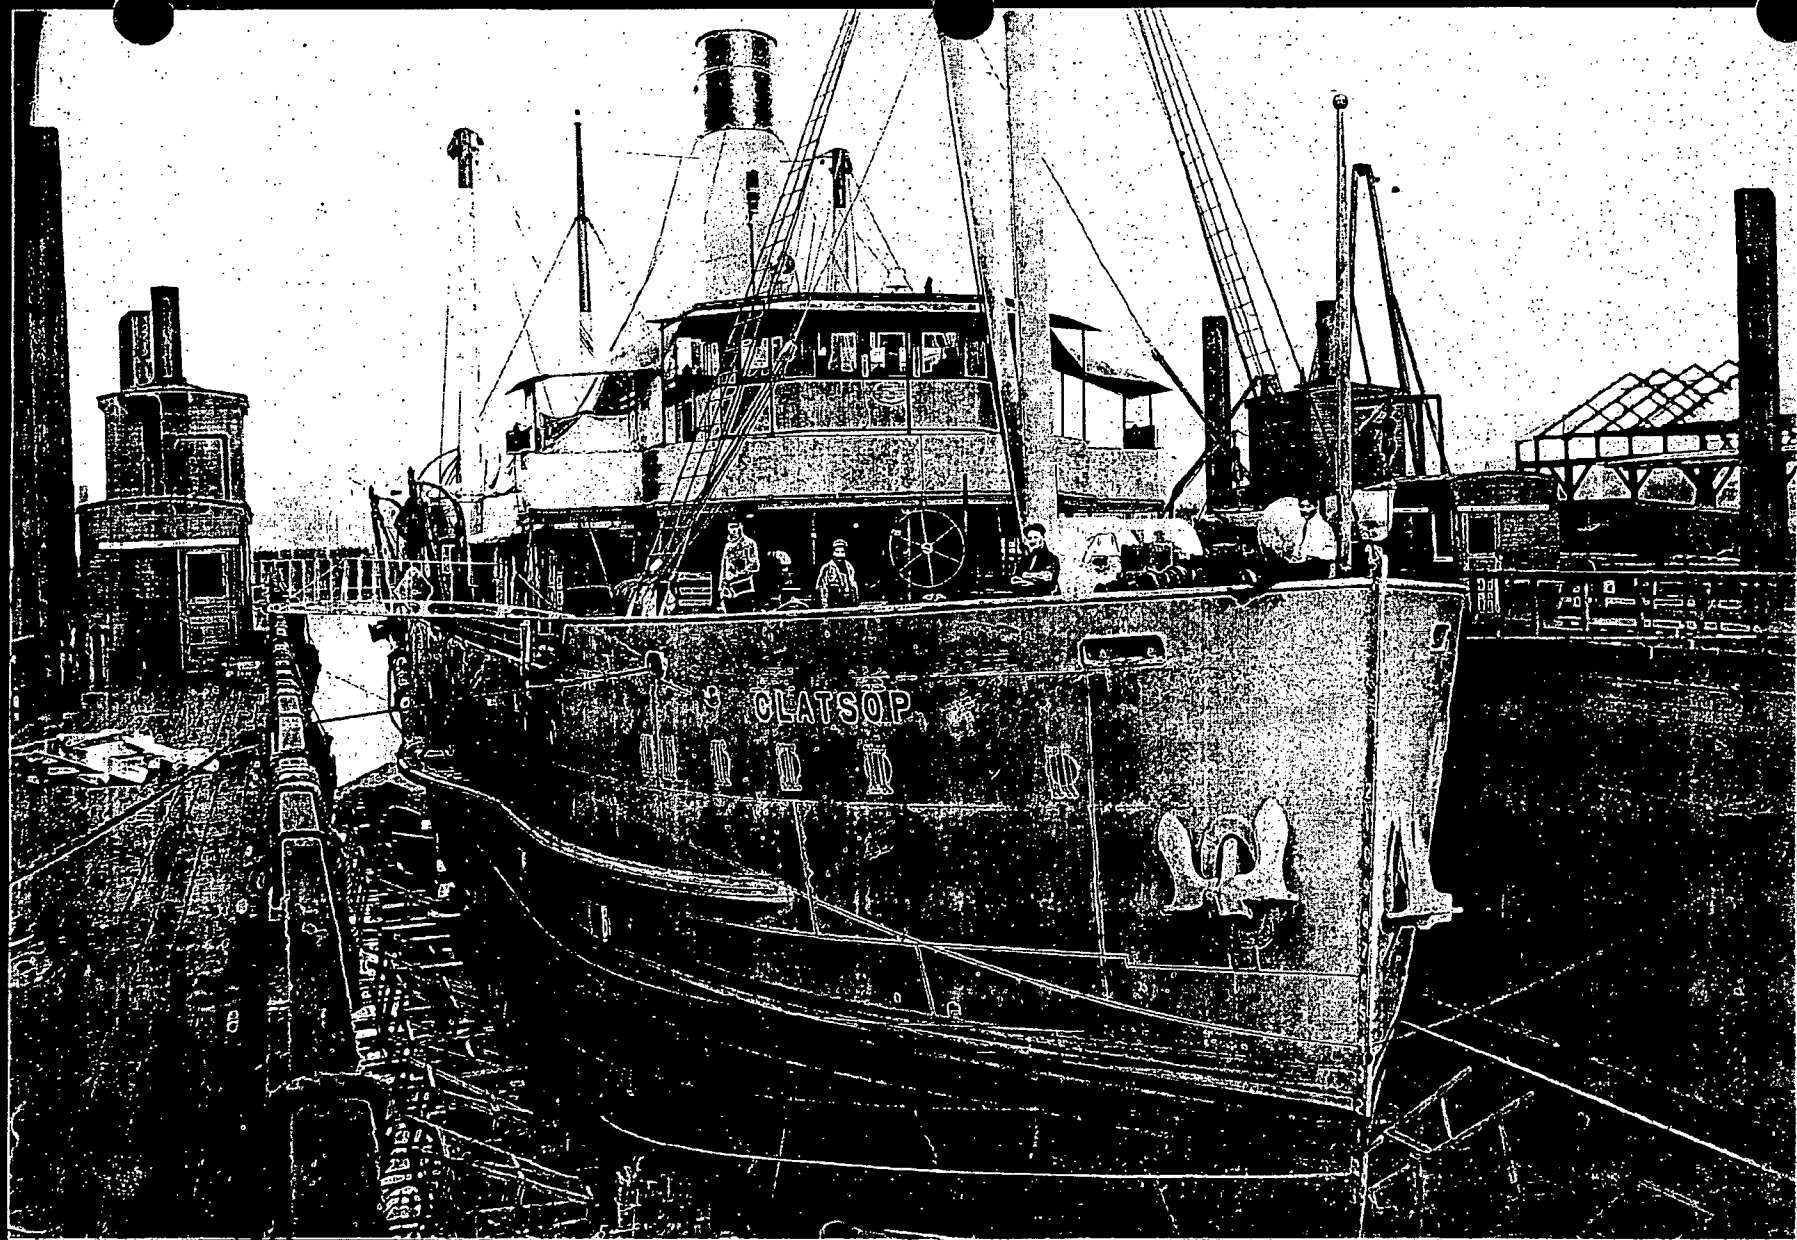
PH DD 1912 4001 00 0001 0

U.S. Dredge Clatsop self propelled and hopper-bottom.  
At Oregon Dry Dock 1912
